February 2012

Great Ruaha River | Main Bridge | 28th December 2011

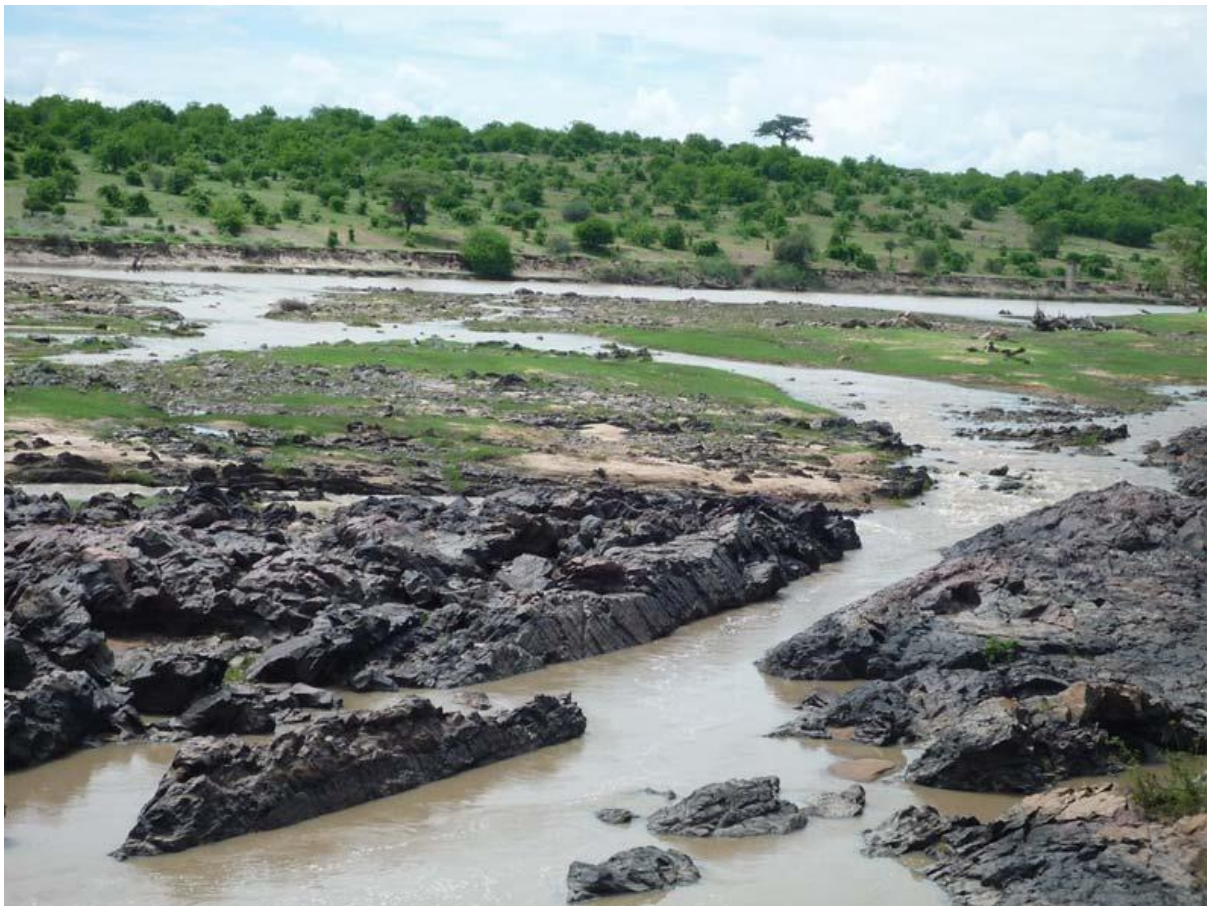
From the onset of the rains in early December, the Great Ruaha River had irregular bursts of flood waters, emanating from the various sand rivers in the park and also in Usangu. This water flowed for several days at a time, all from local rainstorms in different sections along its course, but it was never a constant flow. The picture below shows the flood water from a rainstorm on 27th December 2011. This flow lasted only a few days before drying up again. One can tell it is from local flooding due to its brown colour.

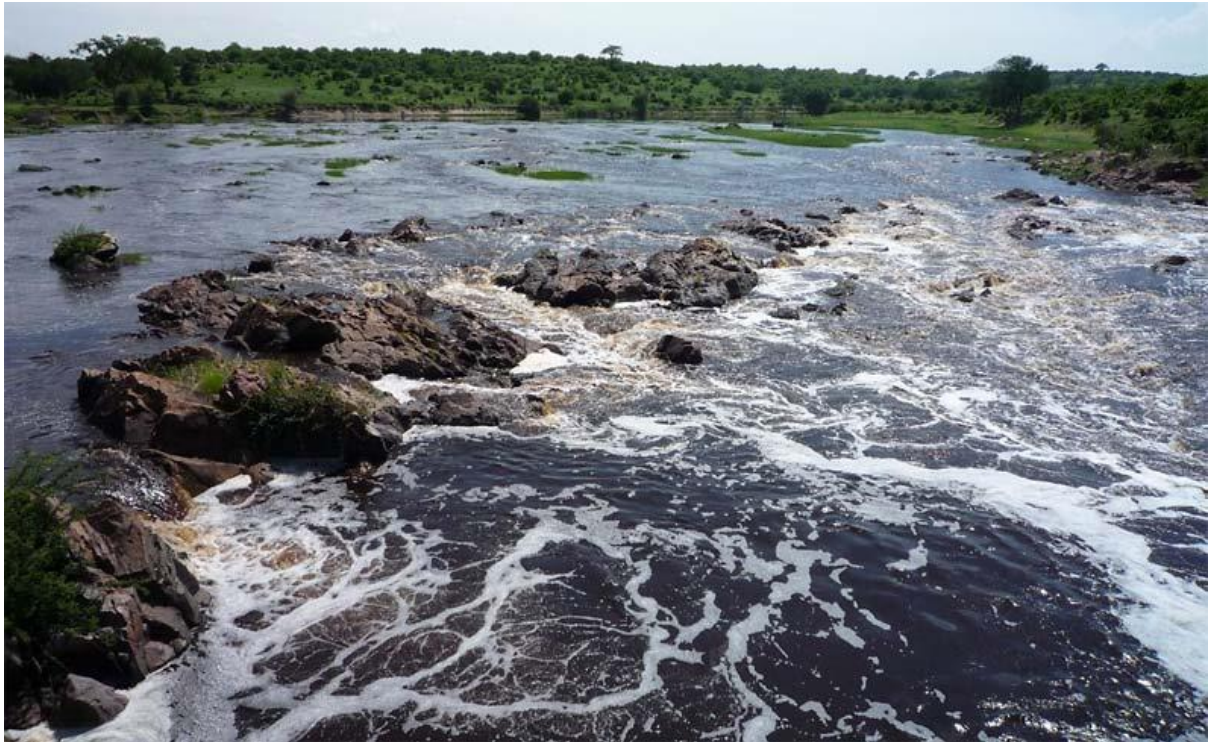
Great Ruaha River | Main Bridge | 28th January 2012

Then, on 17th January 2012 the Usangu water came flowing down the river past the bridge at the old entrance gate (Ibuguziwa). This water flowed on to Lunda. We know this is the Usangu water due to its dark, almost black colour (see photo below).

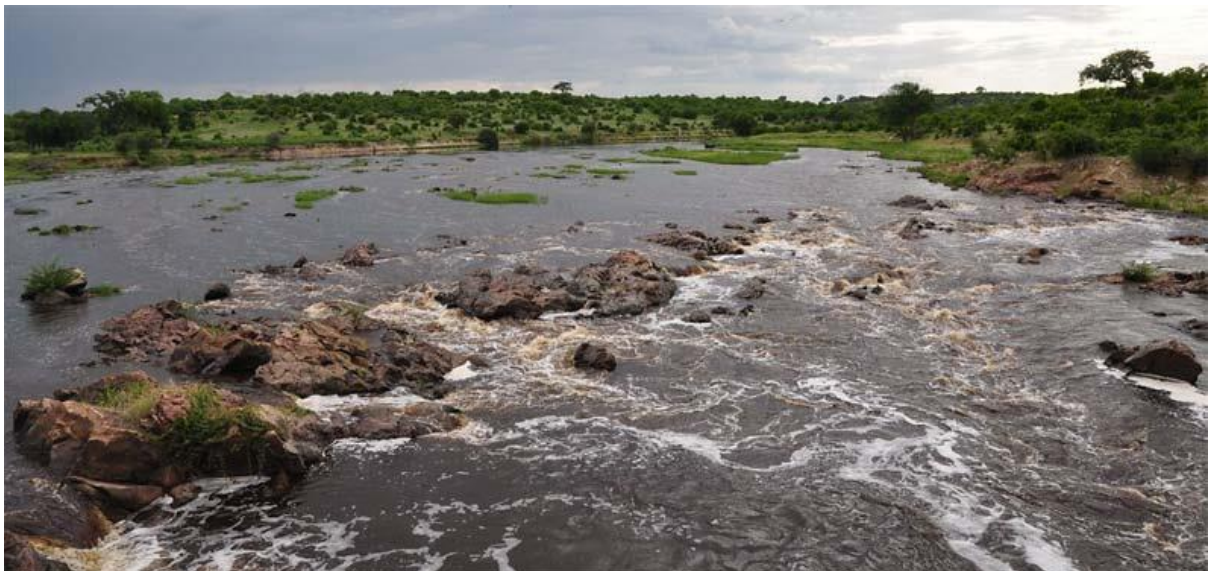
Great Ruaha River | Main Bridge | 6th February 2012

However, as can be seen from the photo below, taken from the same spot some 10 days later, the river level has not risen. It should be doing so if the water was flowing without interruption or abstraction. Also, the water in the photo below is slightly brown, which means that it has mixed with recent floodwater from rainstorms. We know these came from the area just south-west of Jongomero. So, even more reason that the water level should be higher than it was on 28th January. Finally...

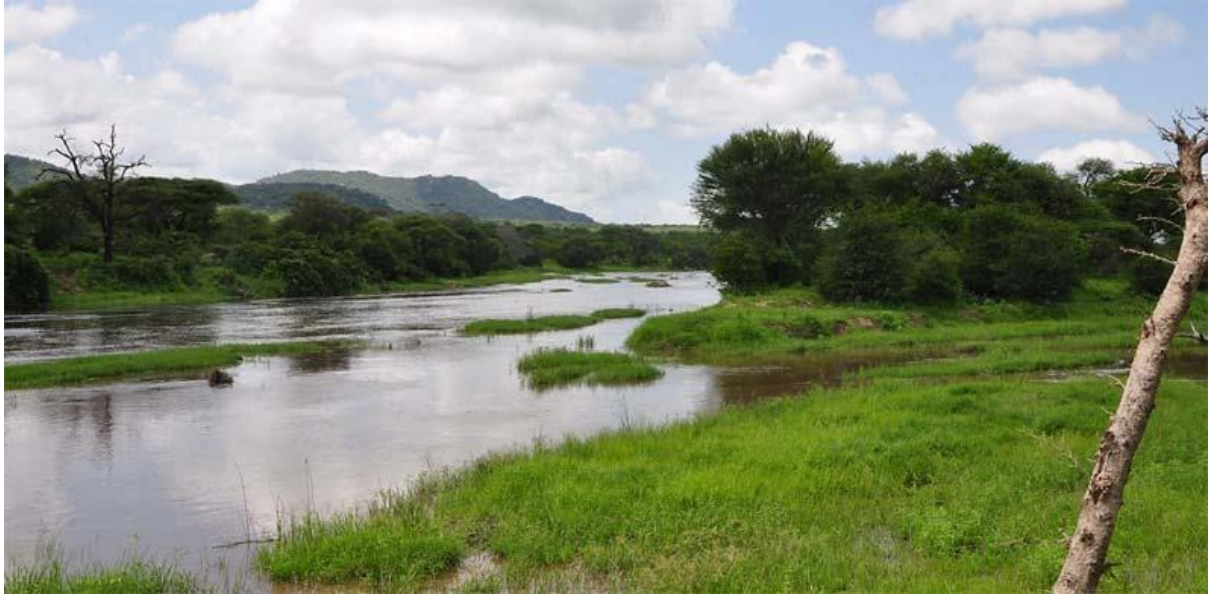
Great Ruaha River | Stone Marker – Sue’s Old Camp | 2nd February 2012

The ever present stone marker at my old camp reveals all. If you look at the 2 photos below you can see how low the river actually is. It is about one third as full as it should be. I suspect that the massive off-takes in the Usangu area are greater than ever before. It is no wonder that Mtera Dam is not filling up very fast. If the water was allowed to flow naturally I feel sure that the river, and hence the dam would be an awful lot higher than what we are witnessing at present.

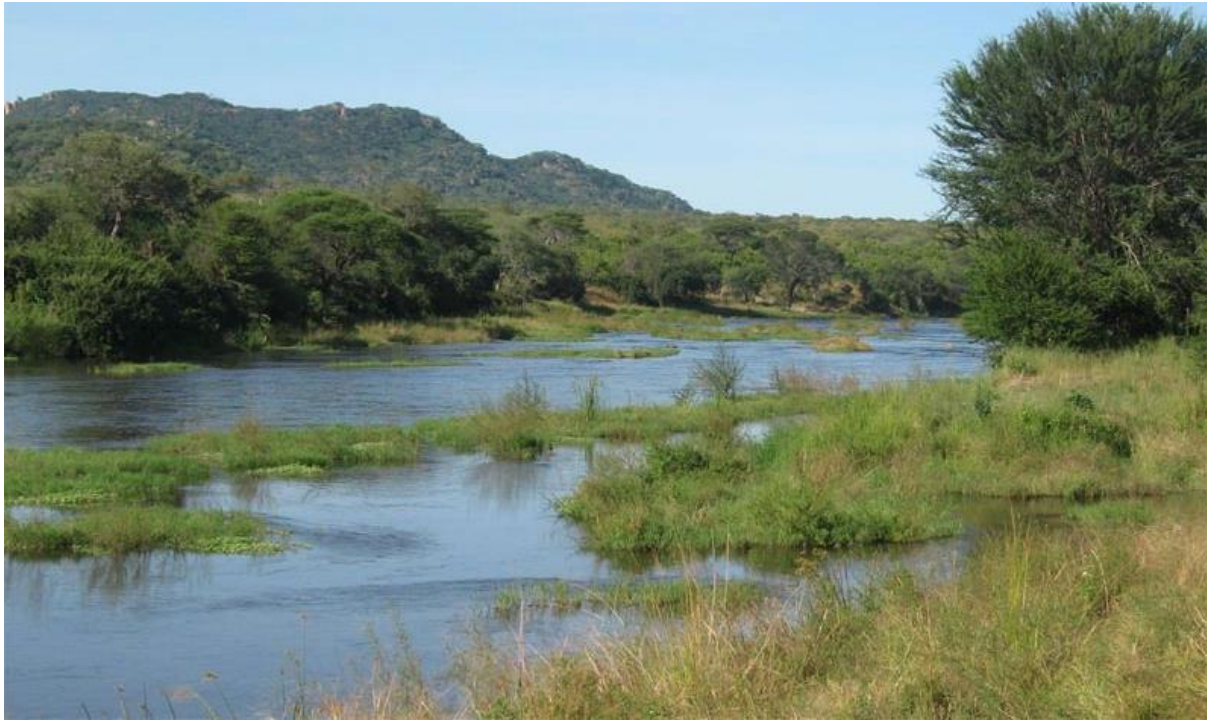
Great Ruaha River | Stone Marker – Sue’s Old Camp | April 2012

The Great Ruaha River has not increased in flow since February 2012. You can see that the grass has grown up without being hampered by any flooding. Therefore, the off-take from the Usangu Basin continues to be in vast quantities. It appears to be more each wet season, leaving less and less to come on through Ruaha National Park to the Mtera Dam.

The rainfall this wet season has been excellent in the catchment area so there has been no shortage there. The river should have covered the stone marker completely, and should remain this way until the end of May.

The first two photos show the river as it was in April 2012, the third photo shows how the river should look at this time of year. This photo was taken two years ago in April 2010. Note there is only the top of the marker showing and no grasslands. The important factor to note is that the rainfall in 2012 was the same as 2010.

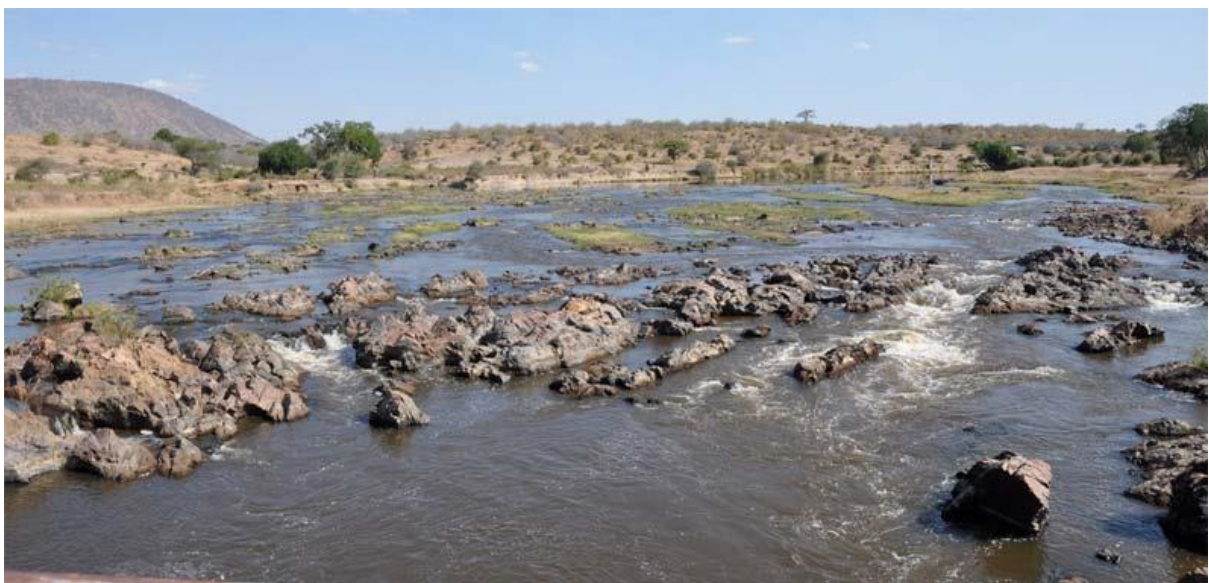
Great Ruaha River | Main Bridge | 15th June 2012

The first photo was taken on 15th June at the main bridge (the old gate - Ibuguziwa). Note that there are two channels flowing.

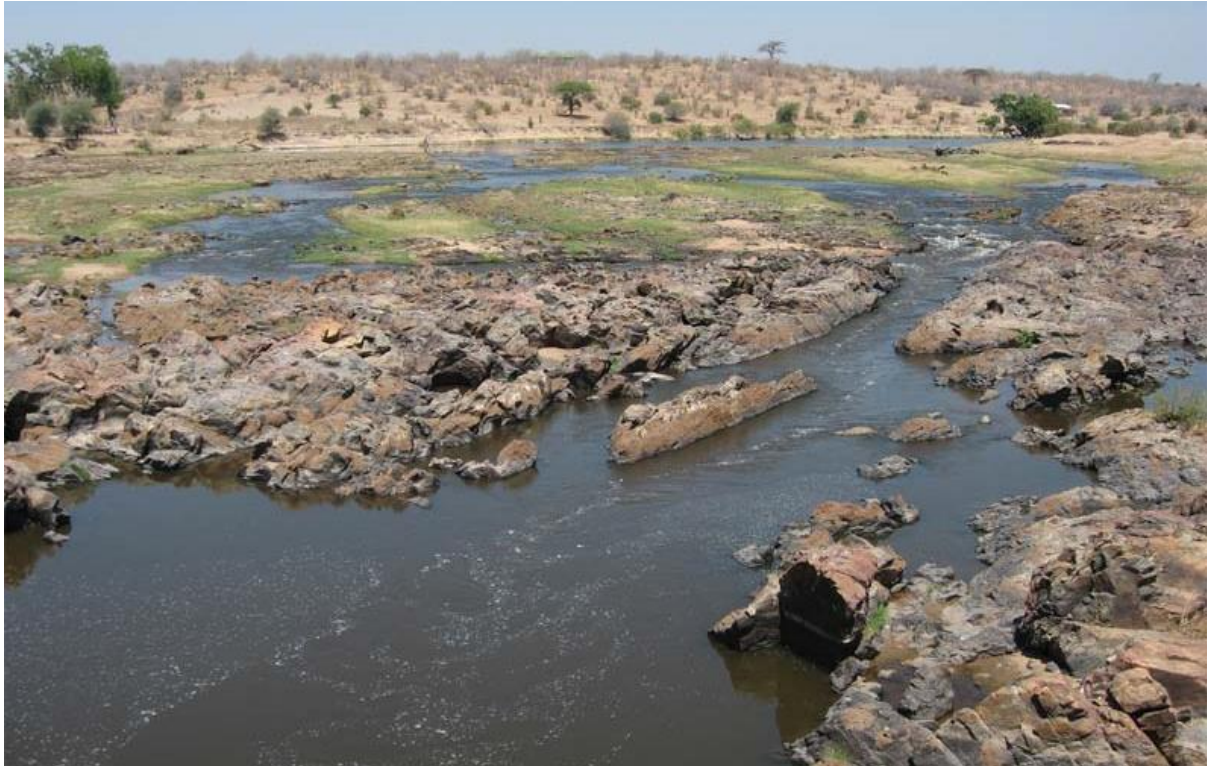
Great Ruaha River | Main Bridge | 30th July 2012

The second photo was taken the other day on 30th July from the same place. There is now only the one channel flowing on the right hand side.

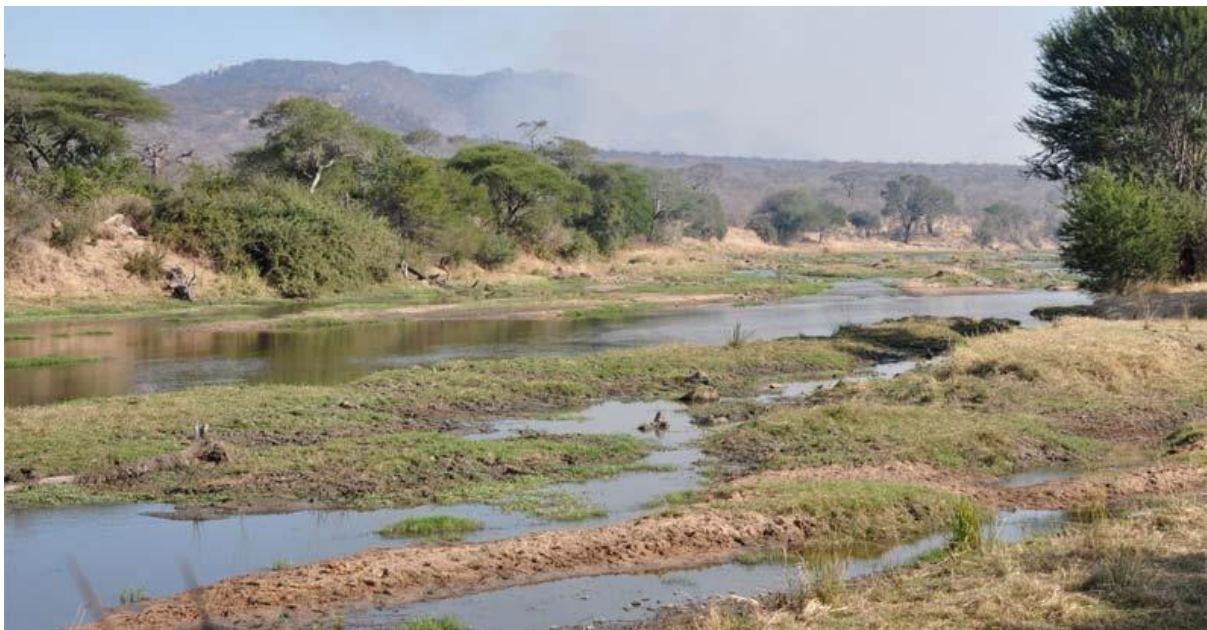
Great Ruaha River | Stone Marker - Sue's Old Camp | 7th July 2012

The final photo depicts the river from my old camp. The stone marker indicates how much the river has fallen. The peak of the wet season flow usually, or should, cover the top of the rock. This year it only reached half way up the rock, presumably due to massive off-take in the Usangu basin.

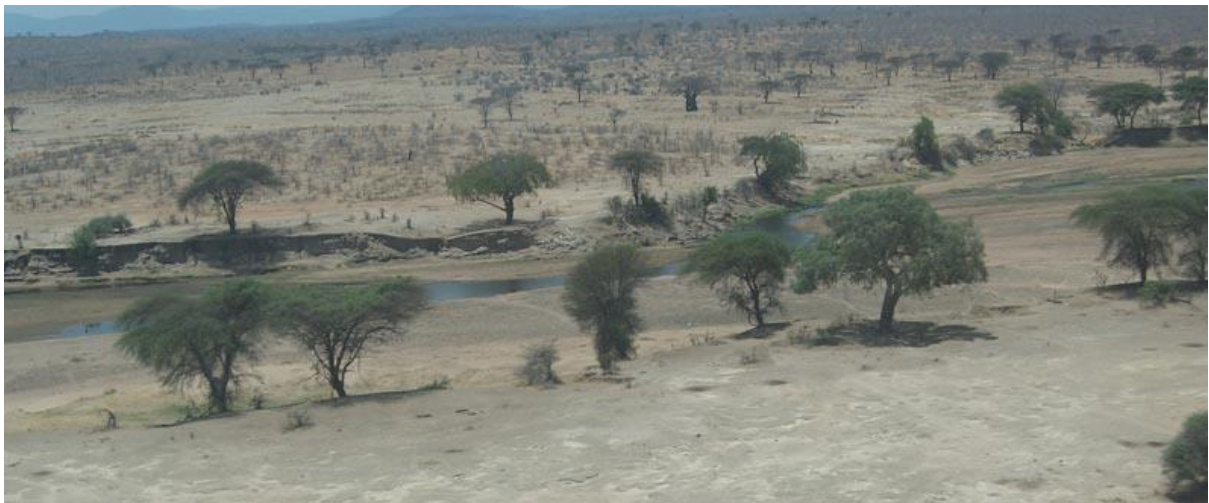
Great Ruaha River | Near Msembe HQ | 23rd October 2012

The river is not in good shape. It stopped flowing at the main bridge (Ibuguziwa) on 20th October. These photos are taken from the air as I left from Msembe on 23rd October. I have been away so have not been able to get photos from the bridge as usual. However, I think that these photos below illustrate the state of the river very clearly.

The surrounding landscape shows clearly how desperately dry it is. The lack of edible vegetation only intensifies the need for drinking water for the animals, great and small. This is always the most testing time for Ruaha, and this year is no exception.

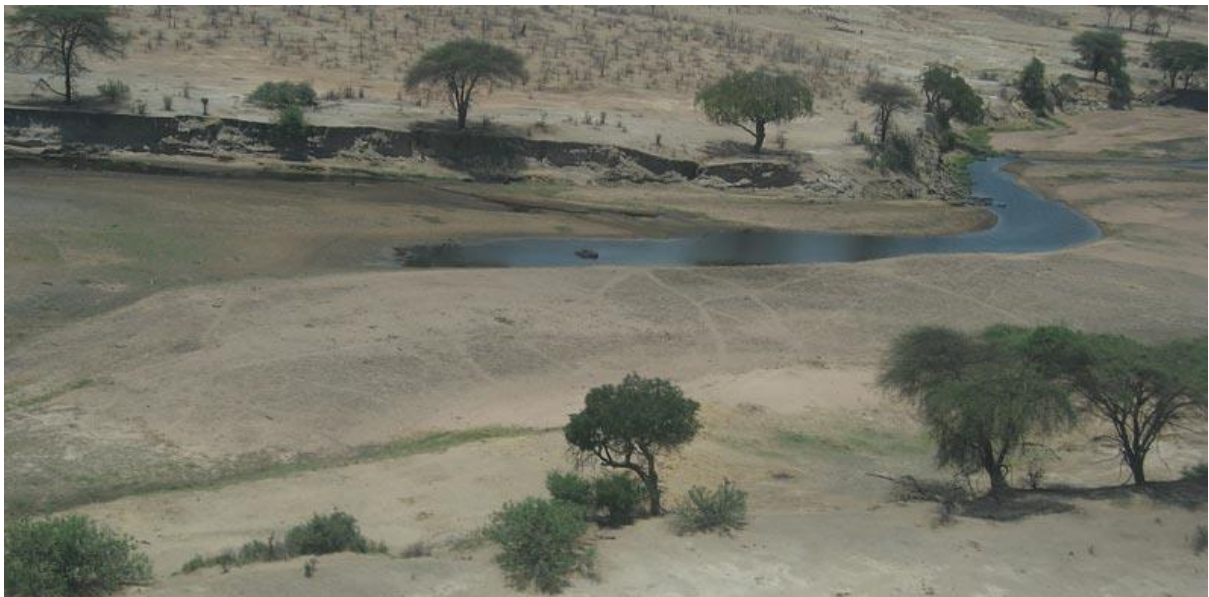
Great Ruaha River | Near Msembe HQ | 23rd October 2012

You can see in the bottom photo (which is more or less opposite Msembe HQ) that the river is most definitely not flowing at that point. Also, there have been reports of masses of dying fish on the Jongomero end of the river, with flocks of Pelicans coming in for the feast.

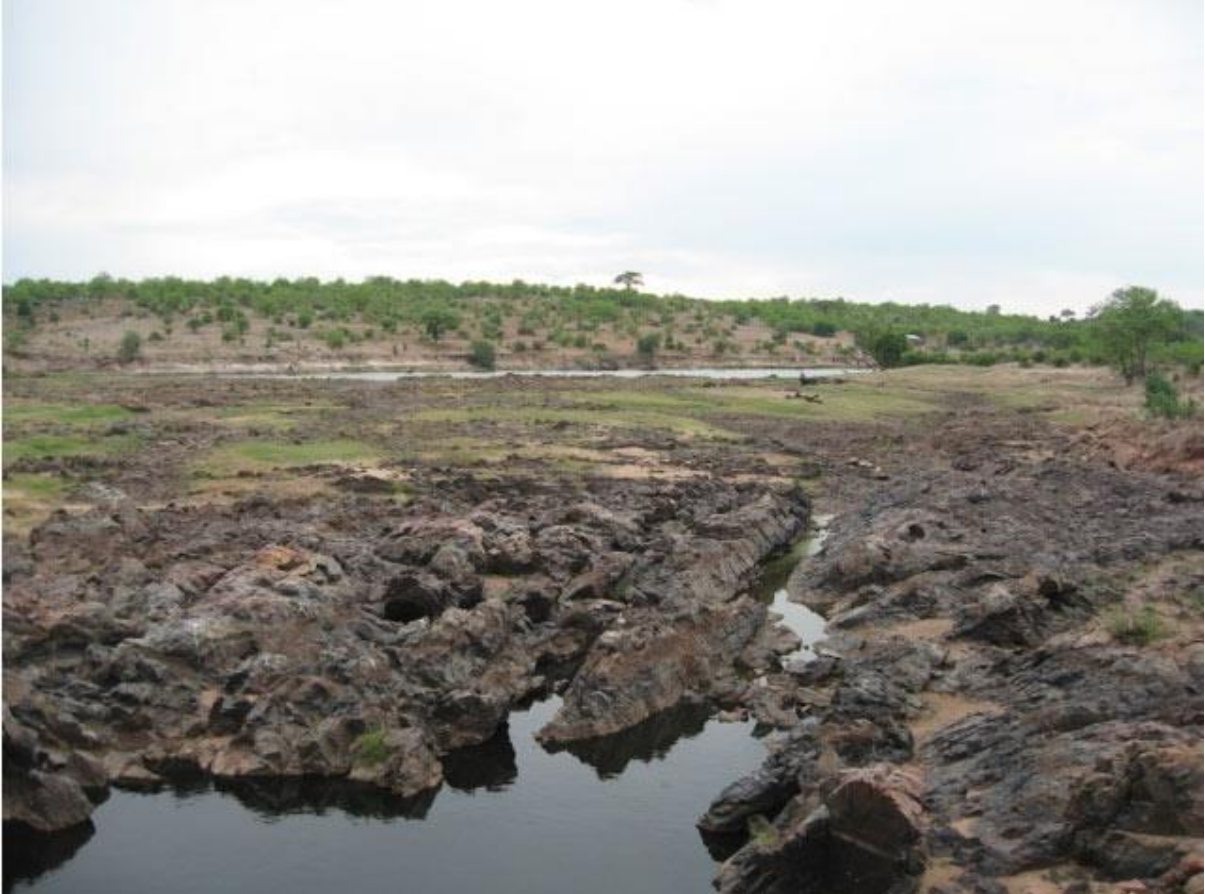
Great Ruaha River | Main Bridge | 22nd November 2012

The photo below was taken on 22nd November 2012 at the main bridge (Ibuguziwa) There is no flow whatsoever in the river.
