Great Ruaha River Water Level | 2011

April 2011

THE GREAT RUAHA RIVER IS NO LONGER A RIVER IT HAS BEEN DESTROYED - 2011 update

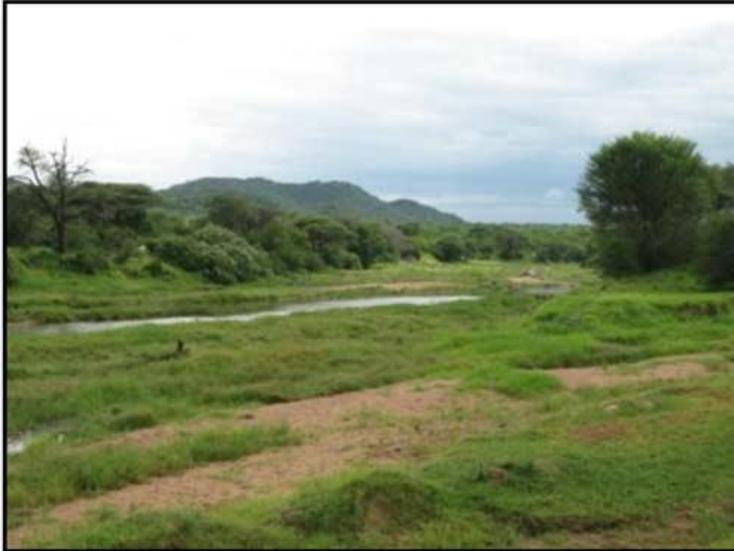
Both these photos are taken from my old camp near Jongomero. You should be familiar now with the stone marker, indicating the depth of the river.

Compare the two photos the one on the left is the **GRR February 7th 2011.**

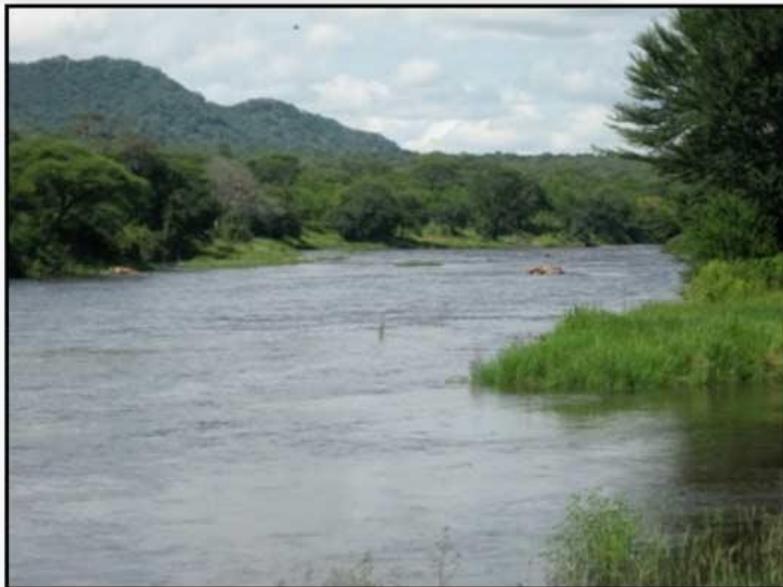
The one immediately below is how the the GRR looked at the **same time last year on the 14th of February 2010.**

It is obvious that the Usangu water was abundant last year.

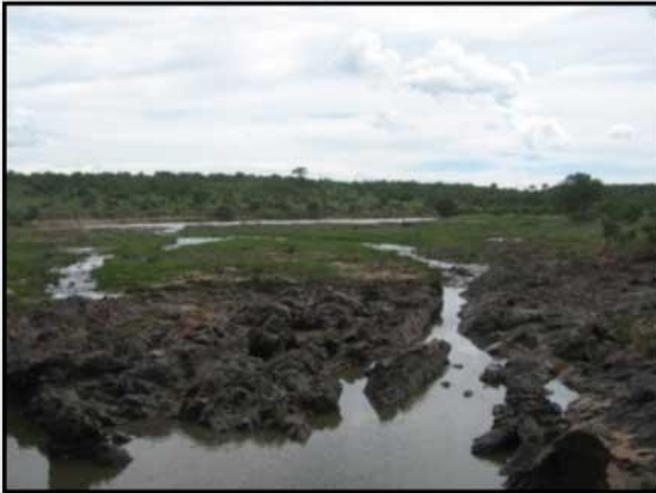
BUT THE USANGU WATER NEVER CAME.

Compare the two photos the one on the left is the GRR **March 29th 2011.**

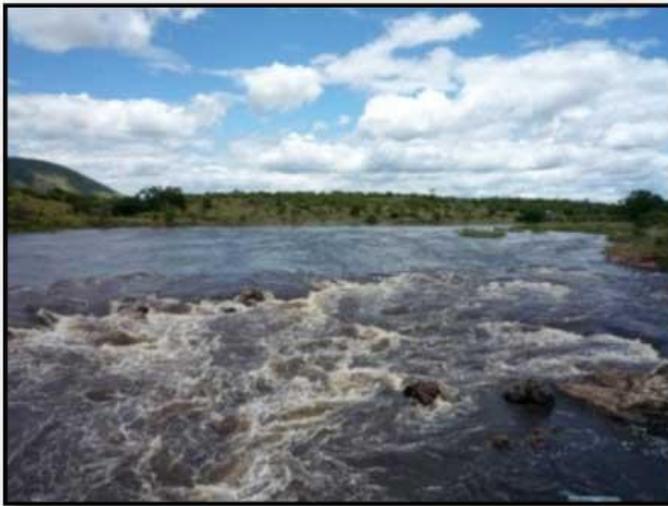
The one immediately below is how the GRR looked at the **same time last year on the 18th April 2010.**

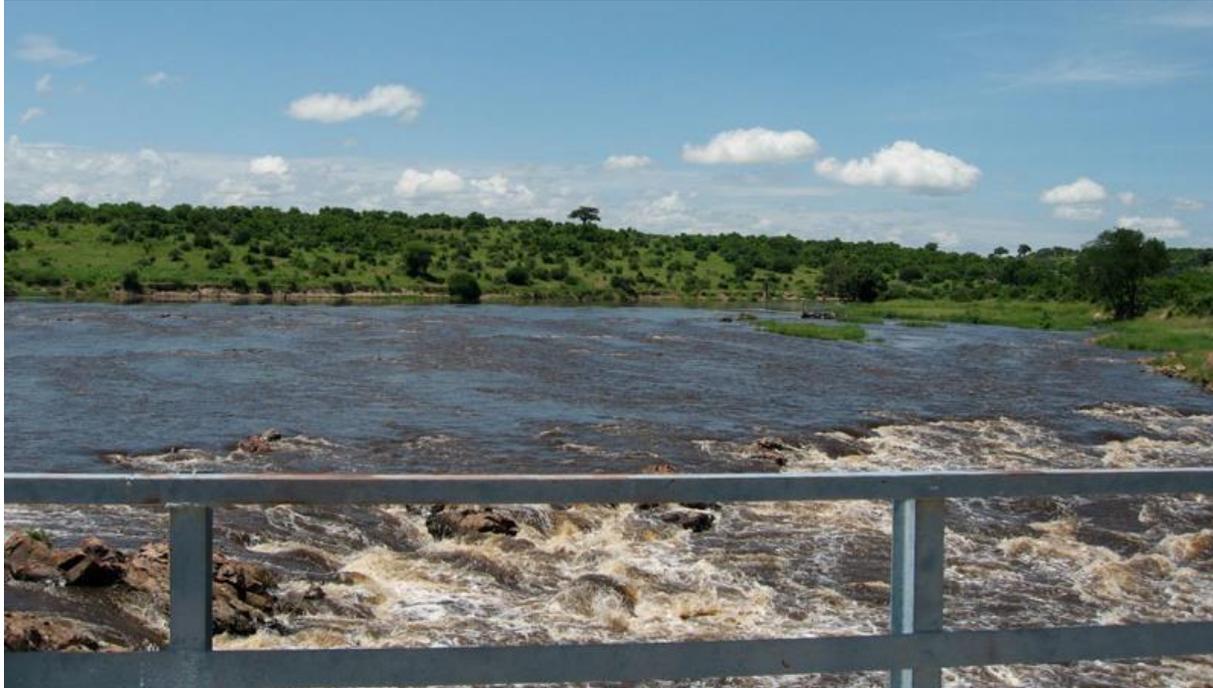
Great Ruaha River | Main Bridge | February 2010

The photo above is the river in February 2010, how the river should look at this time. The photo below is the current situation, on 18th April 2011.

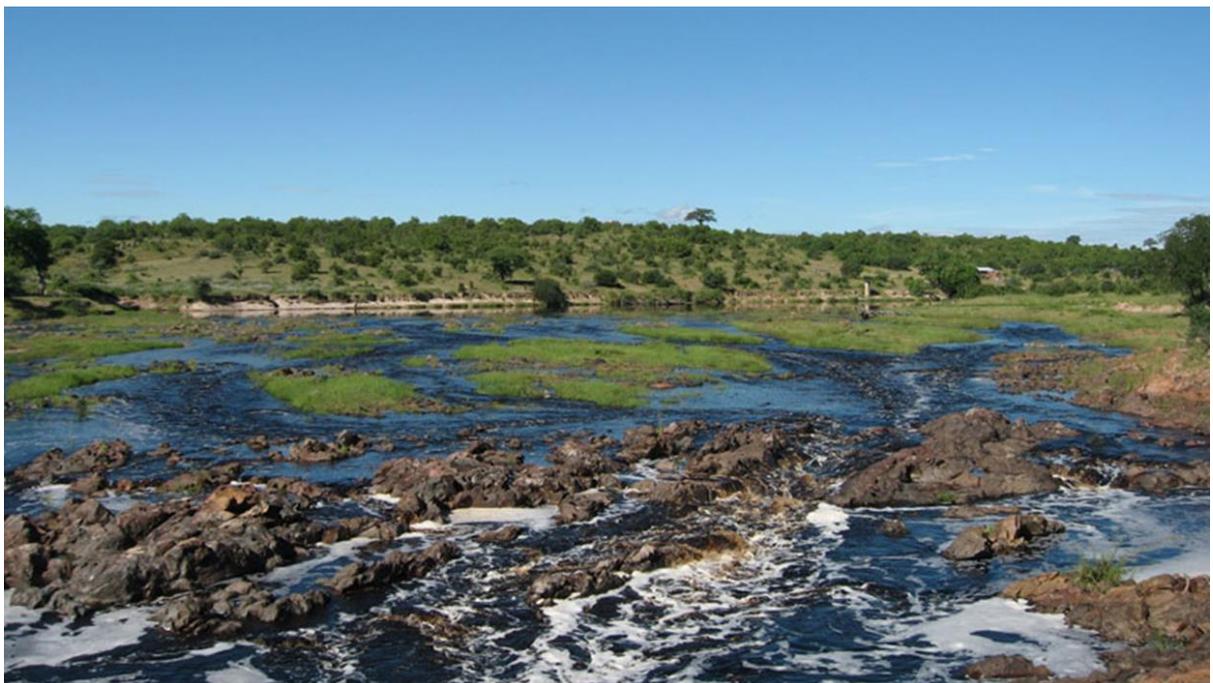
Great Ruaha River | Main Bridge | 18th April 2011

The water is extremely dark brown, almost black, which indicates that it has been sitting in the swamp for a very long time with no movement or fresh inflow of new water. Therefore, the flow into Ihefu is very small so far. We will know if the flow increases when the colour of the water becomes lighter.

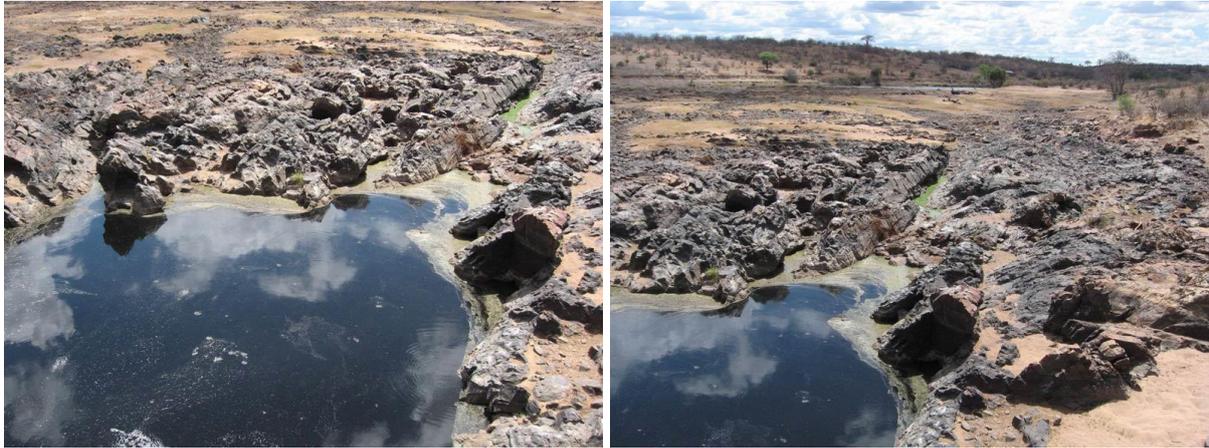
Great Ruaha River | Main Bridge | November 2011

The above photos show a very unpleasant dark rank pool at the main bridge, which is all that the hippos in this area have to live in.

As you can see the water that remains is far from palatable. These two photos were taken on 13th November. I passed over this same spot yesterday, 27th November. The situation is identical to the photos taken earlier in the month; as you can see the situation is not a pretty one. Considering the Great Ruaha River is the focal point of the park and the lifeline for all the animals that it protects, this is a very poor state of affairs.

We do hope that plans are in place to ensure that this wet seasons flows will not be stopped by the massive off takes in the Usangu Basin. Furthermore, we hope that the flows will be sufficient to fill up the now empty Mtera Dam. Perhaps those who are not fortunate enough to be able to afford to run generators will be able to enjoy un-interrupted power this year?
